3 Assessment and Characterization of Damages

3.1 Wind Effects

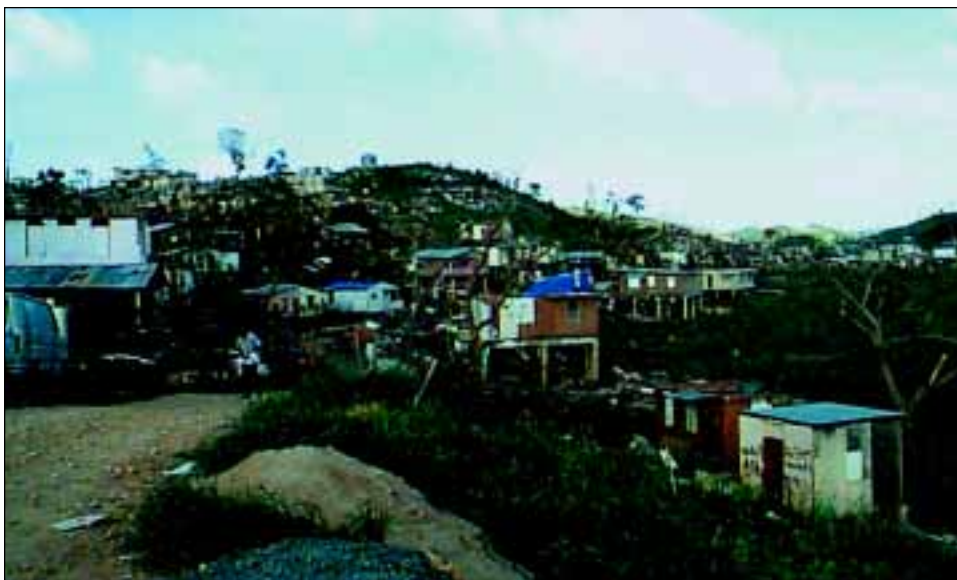
The siting of structures affected the wind forces that acted upon the building. Lower areas were sometimes shielded from winds by hills or mountains. Buildings on high exposed slopes appeared to receive higher wind speeds because of the speedup of the wind up the slopes of the hills or mountains (due to topographic effects and described in ASCE 7-95) (Figures 3-1 and 3-2). The significance of these topographical effects is not recognized in Planning Regulation 7, but is accounted for in the newly adopted 1997 UBC. The 1997 UBC references ASCE 7-95 for the determination of wind speeds. These wind speeds may be adjusted to incorporate topographic effects on wind speeds.

FIGURE 3-1 The abrupt change in topography in this community outside Loiza caused a speedup in the wind that flows over and around the buildings located on the hill beyond. The wind load provisions of Planning Regulation 7 did not account for wind speedup caused by abrupt changes in topography, and therefore underestimated wind loads on buildings situated on hills, mountains, or escarpments.

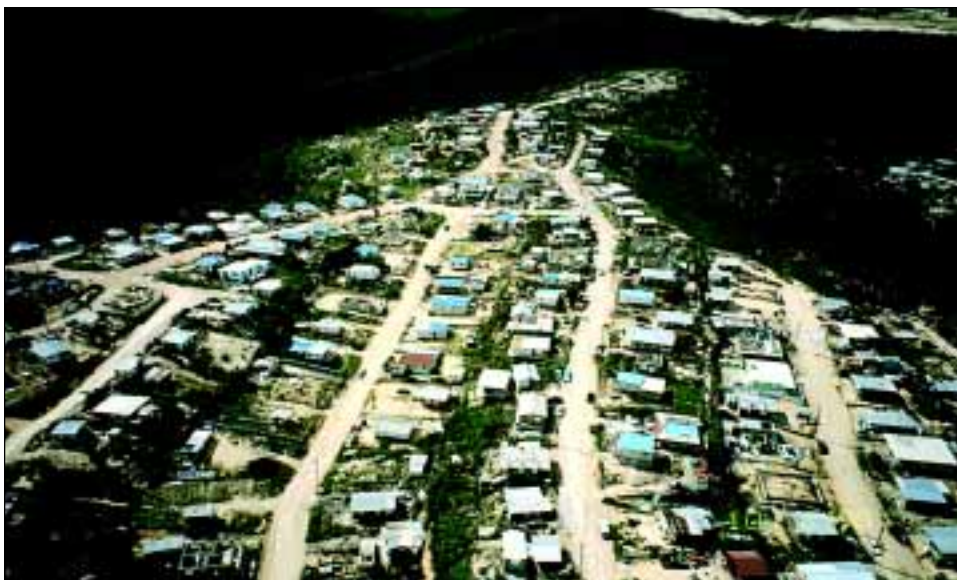
FIGURE 3-2 Wind damage from Hurricane Georges to residential buildings in Puerto Rico. Blue FEMA tarps have been placed on many of the roofs that sustained damage.

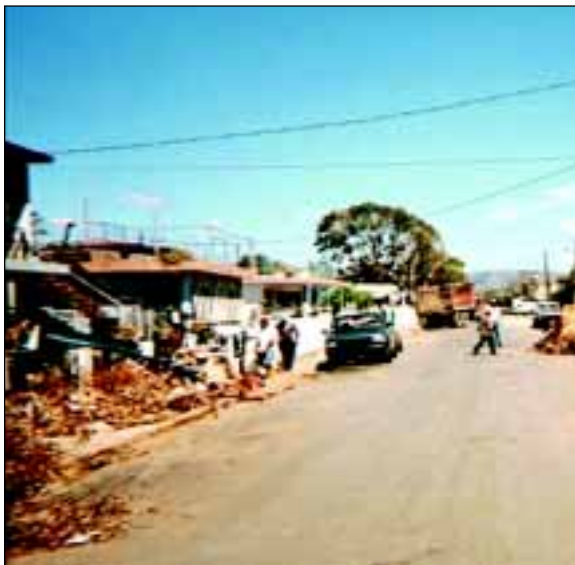
FIGURE 3-3 Typical non-elevated structures in a community located entirely in an SFHA.

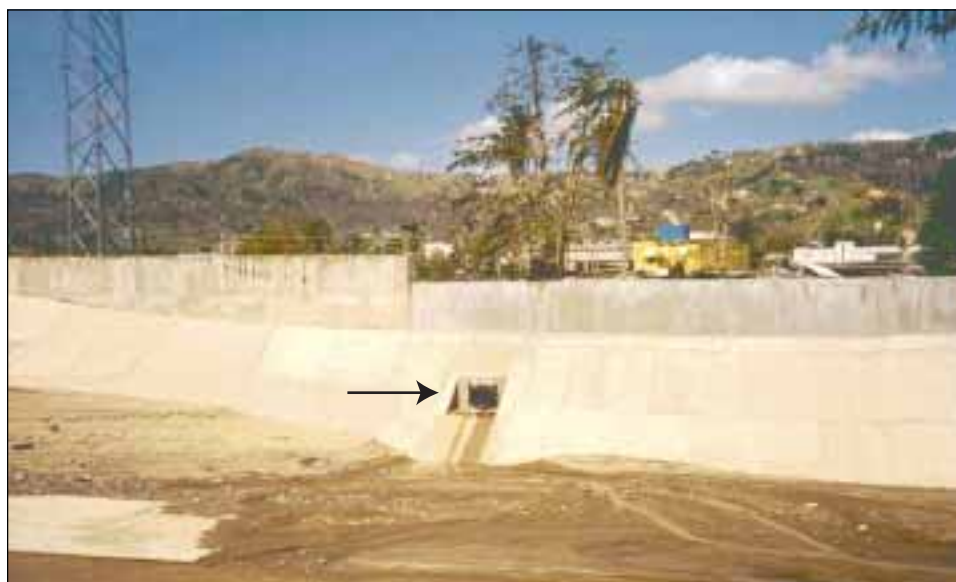
FIGURE 3-4 This flood gate located in Adjuntas prevented backwater from flooding homes located behind it; however, the wall contributed to flooding in the community located on the opposite side of the river, as shown in Figure 3-5.

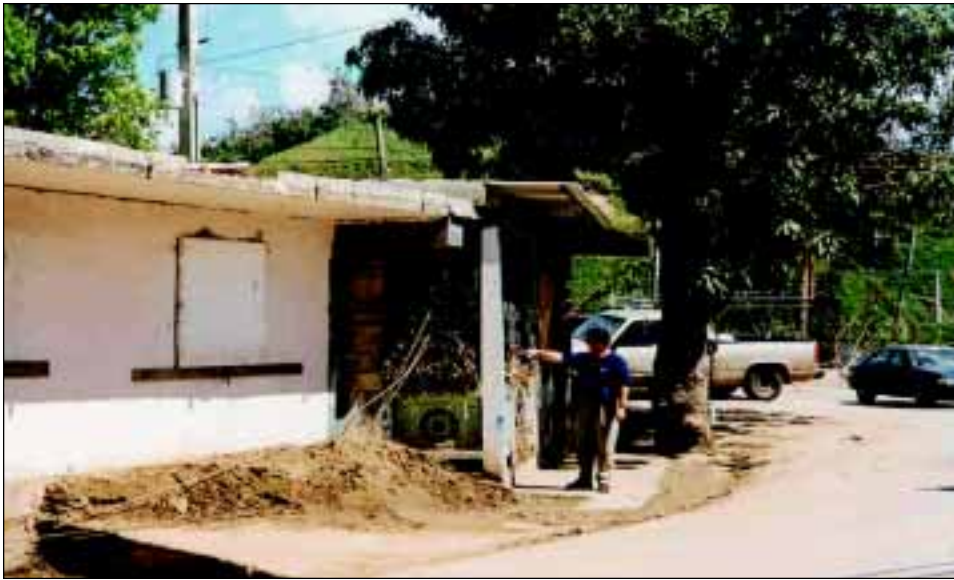
FIGURE 3-5 Residential area on the opposite side of the river from the floodwall in Figure 3-4. The flooding in this area reached a depth of 5 feet.

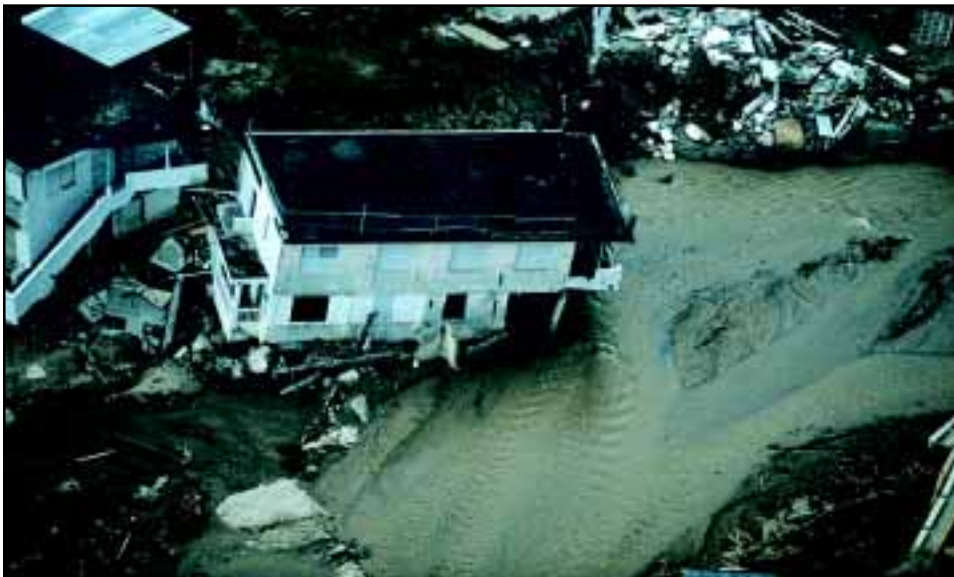
Flooding damage fell into two categories: buildings inundated by floodwaters that caused much of the building and contents to be wet, but no structural damage; and buildings with structural damage, where the foundations were undermined by floodwaters. Almost all flood-damaged homes fell into the first category. Figure 3-3 shows a typical non-elevated structure in a community located entirely in an SFHA that was damaged by Hurricane Georges. Figure 3-4 depicts a flood control measure that protected homes on one side of the river. Figure 3-5 is an example of the damage caused to the area along the river opposite the floodwall in Figure 3-4. Although these homes were severely flooded, they experienced minimal to no structural damage. Figures 3-6 and 3-7 illustrate cases where flooding undermined the building foundations.

FIGURE 3-6 Floodwaters eroded soil and undermined the foundation system of this building.

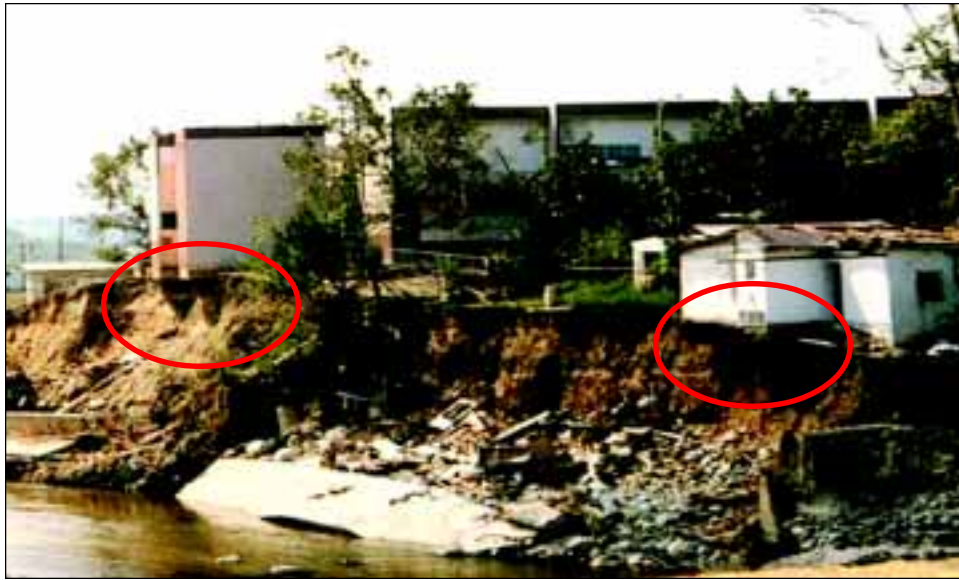
FIGURE 3-7 Riverbank erosion resulted in the undermining of the building foundations of a school (pink building) and house (white building) in Jayuya.

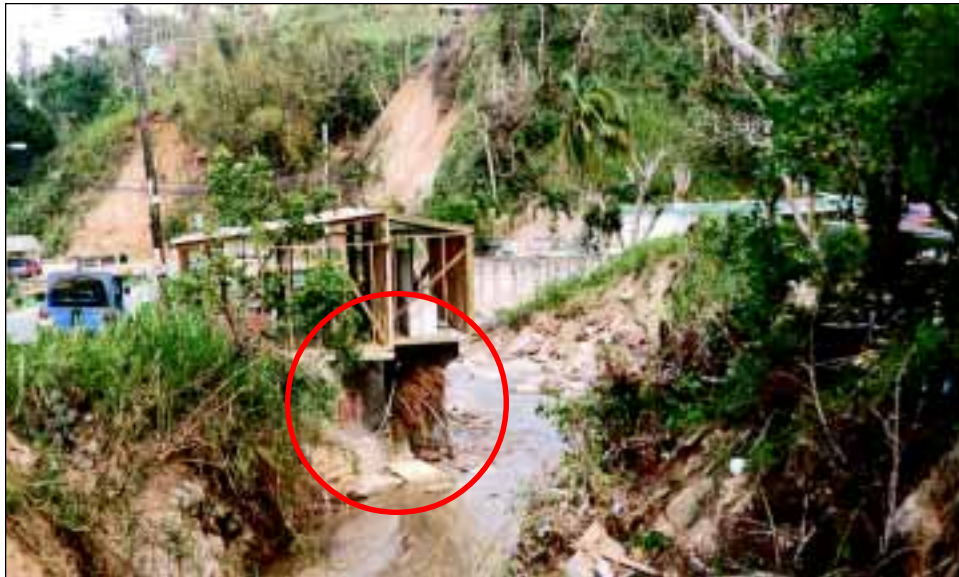
Siting of homes in floodprone areas, such as river and stream beds, was observed throughout Puerto Rico. Figure 3-8 illustrates a home constructed adjacent to and over an existing stream. Structures constructed in this manner are vulnerable to damage from floodwaters.

FIGURE 3-8 Typical construction adjacent to and over the river. Note the debris trapped under the concrete foundation and between the framing.

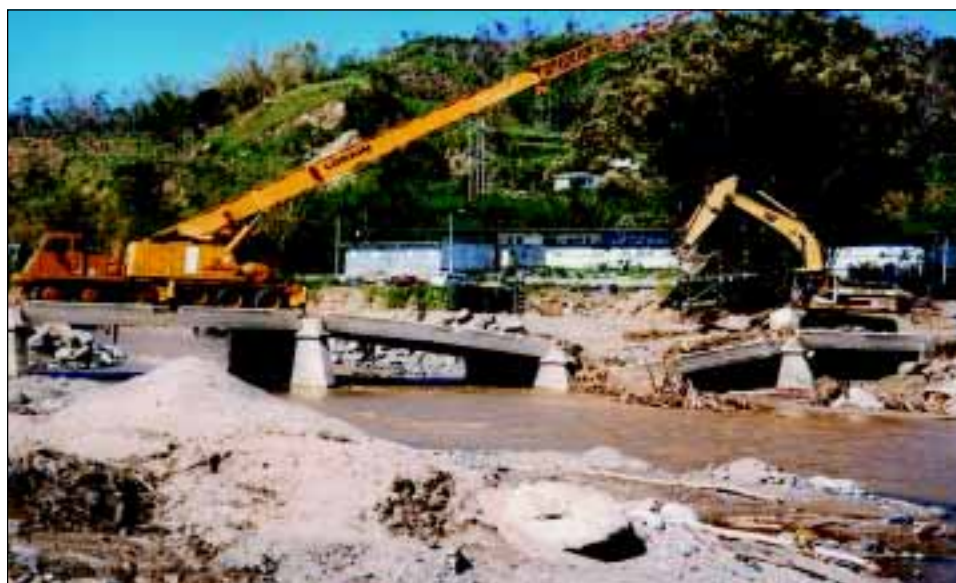
FIGURE 3-12 This bridge outside Adjuntas collapsed due to insufficient design to resist the effects of floodwaters.

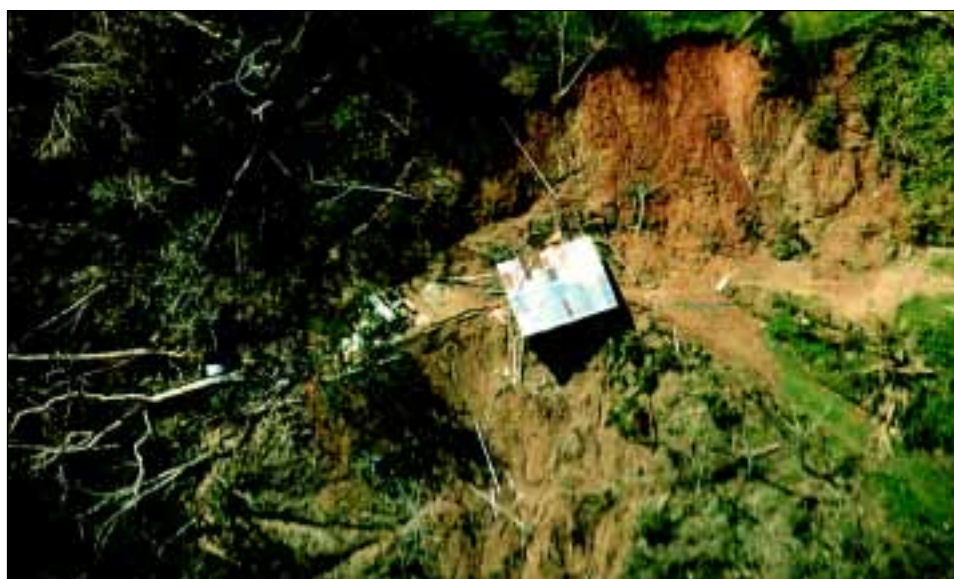
Puerto Rico's steep topography and shallow, sandy soils over bedrock make it susceptible to landslides. During Hurricane Georges, widespread rainfall in the more mountainous regions of the island resulted in numerous landslides that blocked and undermined roads, and even destroyed homes (Figures 3-14 and 3-15). This will become a greater problem in the future as more developments and houses are constructed in regions prone to such risks. A more detailed review and analysis of this problem needs to be undertaken. Figure 3-16 illustrates problems with unrestricted development. Many single-family homes are located beneath a cut that is void of vegetation, making the slope susceptible to landslides.

FIGURE 3-14 Aerial view of a now uninhabitable house caught in a landslide.

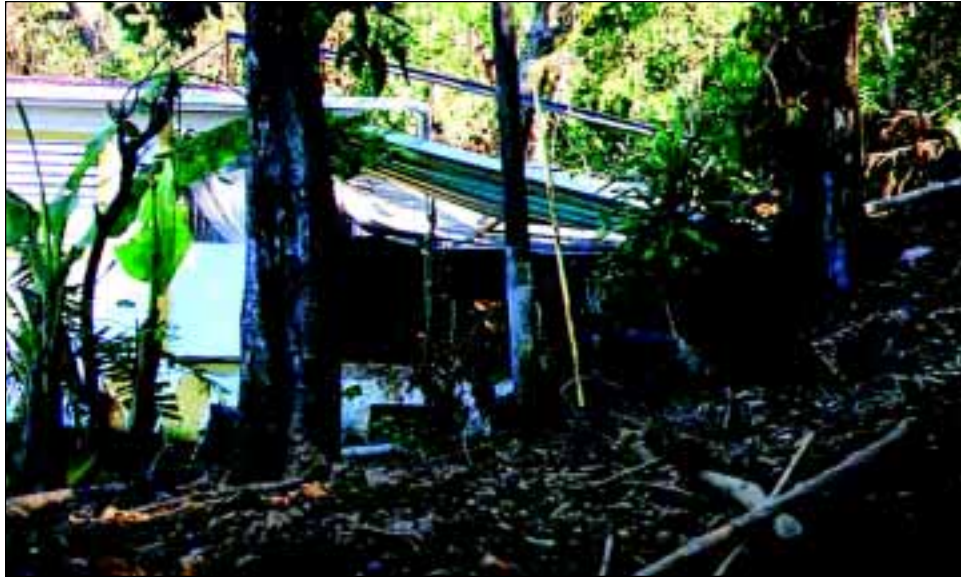
FIGURE 3-15 A landslide inundated this house with up to 5 feet of soil.

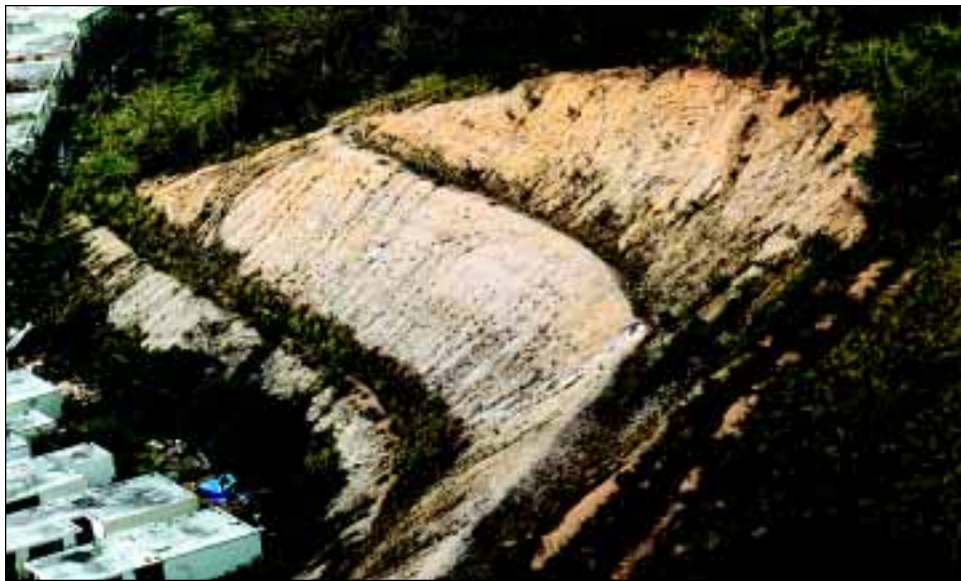
FIGURE 3-16 Development adjacent to a representative unprotected cut; the potential for future landslide activity exists.

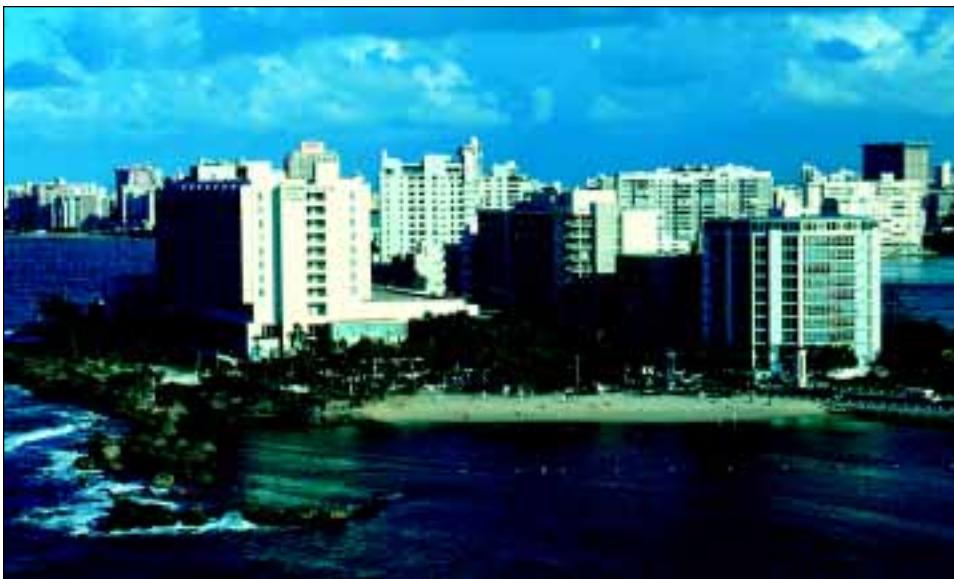
FIGURE 3-17 Commercial concrete structures with no structural damage. These structures are located to the east of Old San Juan.

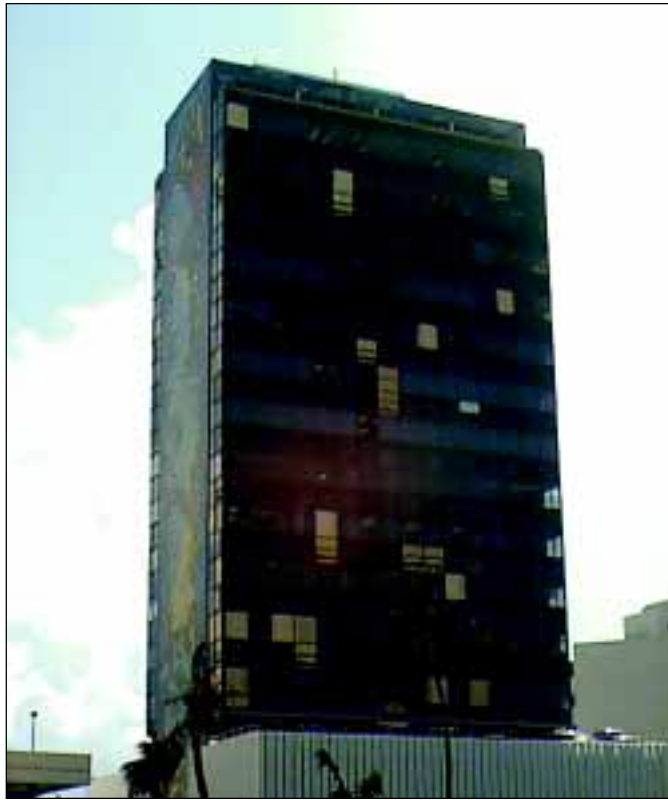
Both residential and commercial buildings constructed of concrete/masonry with concrete roof decks were investigated. Figure 3-17 shows commercial buildings of concrete construction with concrete roof structures. These large buildings performed well structurally during Hurricane Georges. Many, however, experienced significant interior damage and property loss due to breach of the building envelope. Loss of exterior windows due to wind and windborne debris was the primary damage observed (Figure 3-18).

FIGURE 3-18 Commercial concrete structure with interior damage due to breach of building envelope (failed windows). Note: Plywood sheets were installed after the storm to cover broken windows; they were not present prior to the storm.

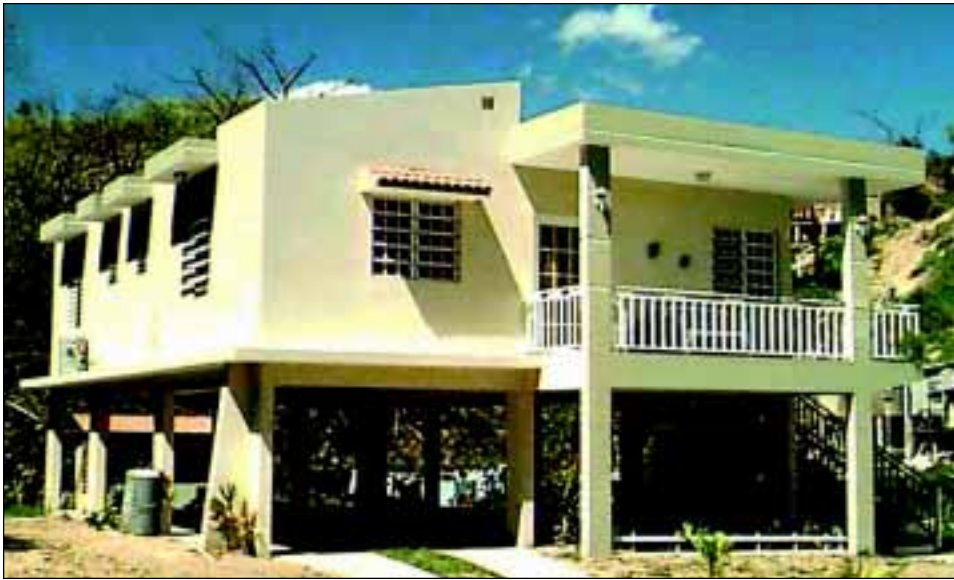
FIGURE 3-19 Residential concrete structure in the mountains north of Adjuntas with no structural damage following Hurricane Georges.

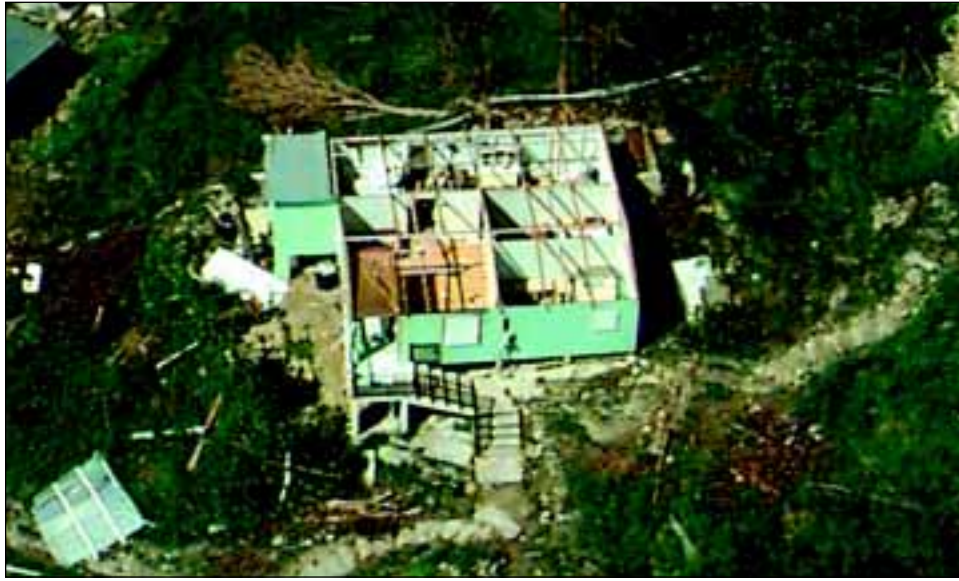
Most roofs inspected were gable roofs; the remainder were low-slope (flat roofs) and hipped roofs. Figure 3-20 represents a single-family home with a wood-frame gable roof structure that experienced a typical roof failure. Failure of roof structures at gable ends has been well documented following previous hurricanes, especially when insufficient attention has been paid to connection details at the masonry walls or to bracing the gable end wall. This was the case in Puerto Rico.

FIGURE 3-20 Aerial view of a residential concrete/masonry structure with a wood-frame roof structure; only the roof rafters remain. The wood nailers and metal panels were blown off.

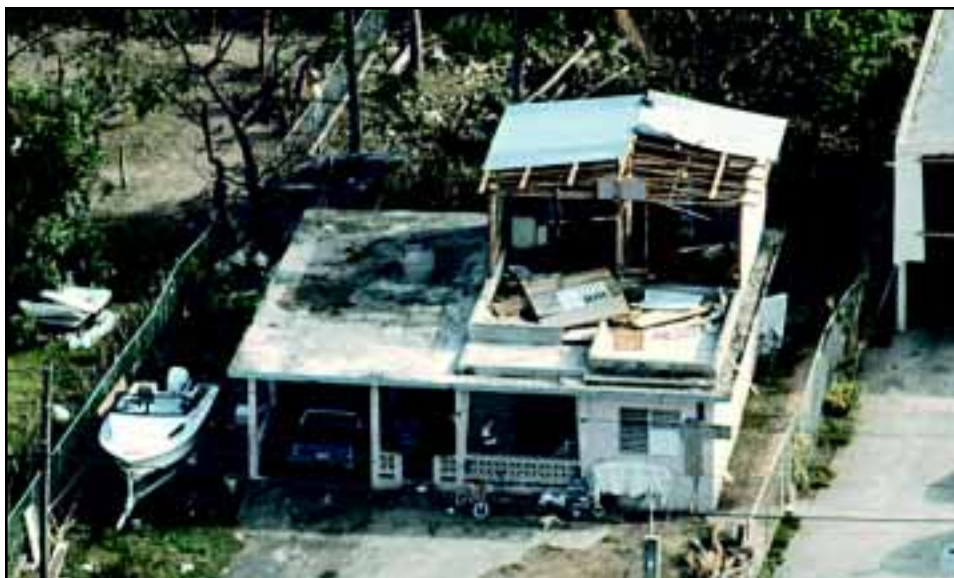
FIGURE 3-21 A combination residential concrete/masonry structure with an elevated second-floor concrete slab and a wood-framed upper level. Note the lack of damage to the concrete/masonry section of the house and the damage to the wood-frame portion.

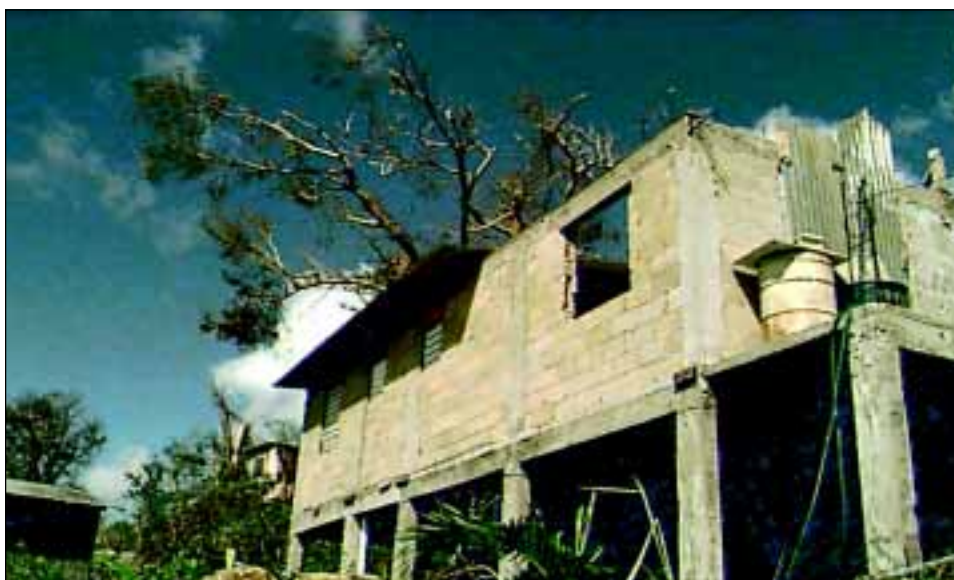
FIGURE 3-22 A residential concrete/masonry structure that is under construction. The photograph illustrates this common building practice: concrete columns with unreinforced masonry block infill walls. This is not seismic resistant construction.

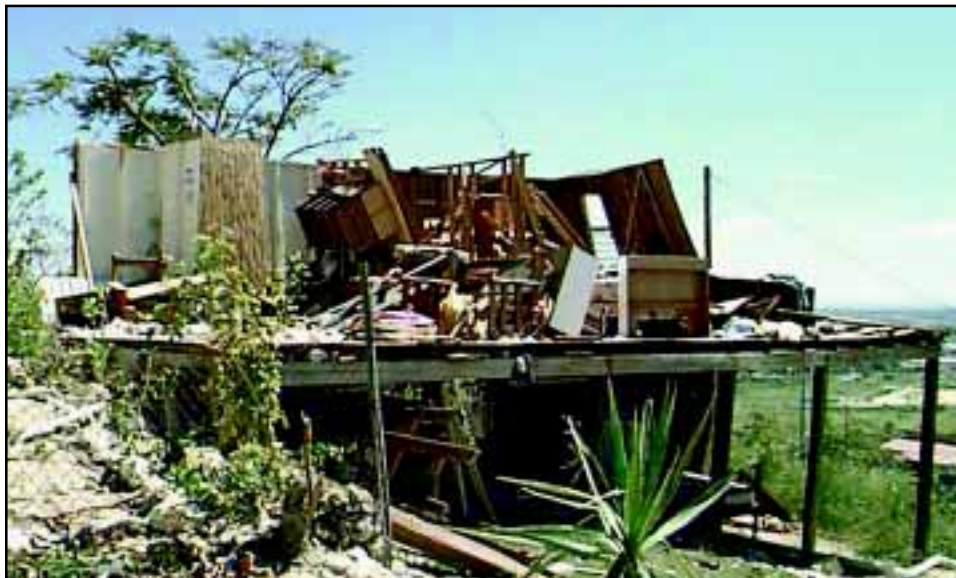
FIGURE 3-23 A residential wood structure located on the hilltops west of Ponce destroyed by wind. The roof system has been removed and the wall system partially collapsed.
